**FIVE-YEAR REVIEW REPORT FOR
NL INDUSTRIES/TARACORP LEAD SMELTER SUPERFUND SITE
Granite City, IL**

**U.S. Environmental Protection Agency
Region 5
Chicago, IL**

3/28/2014

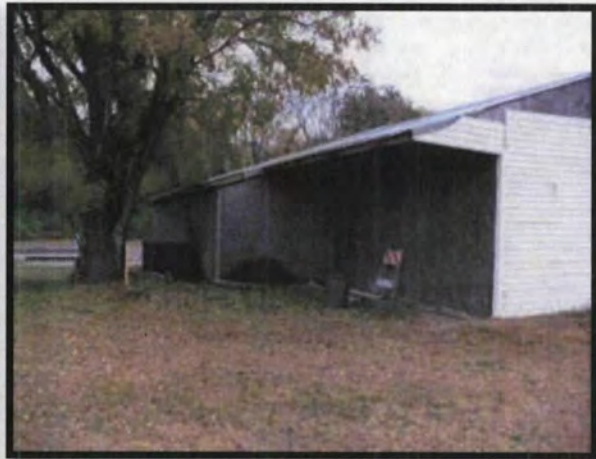
Photograph 16: Robin's Nest Lounge at Slough Road; north side of building.

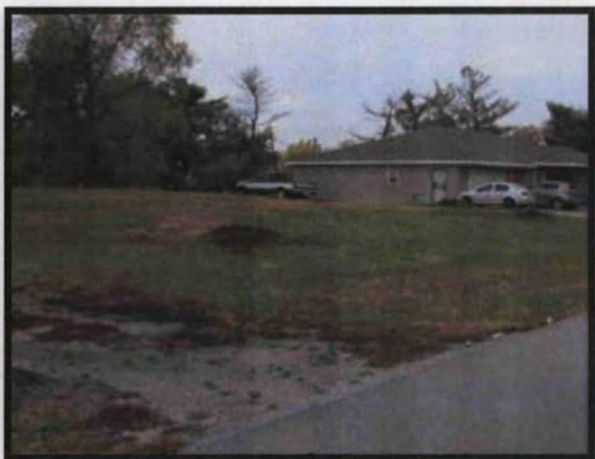
Photograph 6: Eagle Park Acres – former soil pile area 2 along Watson Street (soil piles from ACOE sanitary sewer installation project have been removed and property has been revegetated).
